Total System Failure on 09th December 2023

**PRELIMINARY REPORT ON TOTAL SYSTEM
FAILURE
AT 17:03:50 HRS ON 09th DECEMBER 2023**

Control & Protection Branch,
Transmission Division,
Ceylon Electricity Board,
Kent Road,
COLOMBO 00900
Date: 10.12.2023

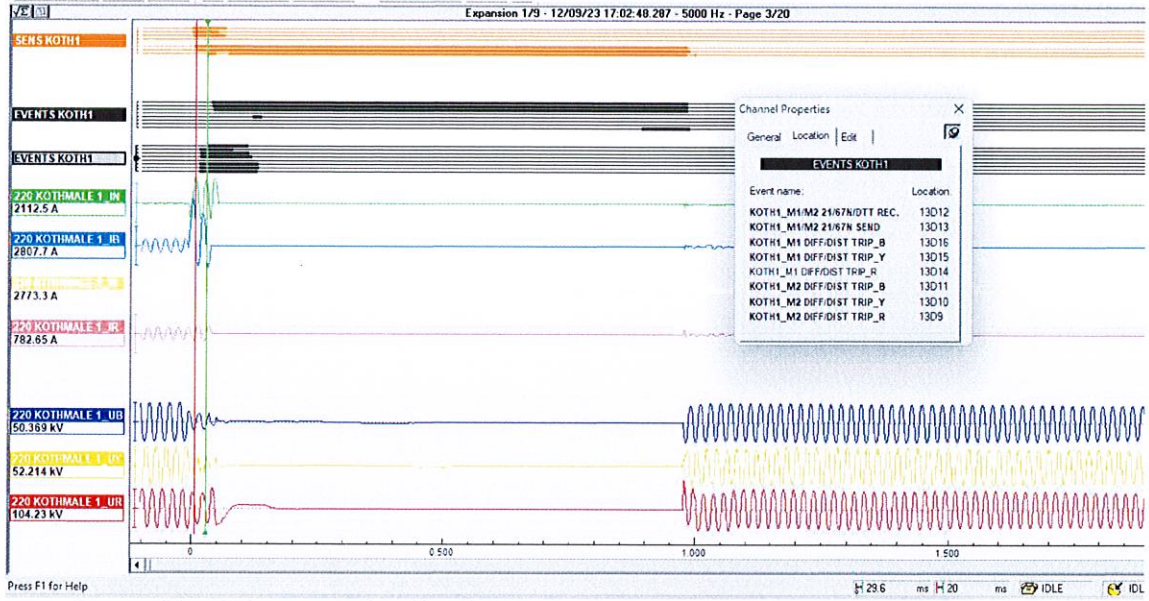
Figure 02: DDR record of Kothmale Line 1 of Biyagama GSS at 17:02:48 Hrs

- (1) Biyagama - Kothmale 220kV Line 01 and 02 tripped from both ends due to the operation of Line Differential Protection at 17:02:48 hrs. Multi phase (Y-B) to earth fault of magnitude in the range of 4kA has occurred in both lines resulting in the tripping of all three phases and clearing the fault within 50ms by the operation of line differential protection of both Main 1 and Main 2 protection relays. Both lines reclosed from Biyagama end after elapse of the dead time of 800ms. (Refer figure 2,3,4 & 5) Reclosing from Kothmale end was not attempted since the phase angle of the bus voltage and line voltage exceeded the synchronism check setting value of 20 degrees. (Refer figure 12)

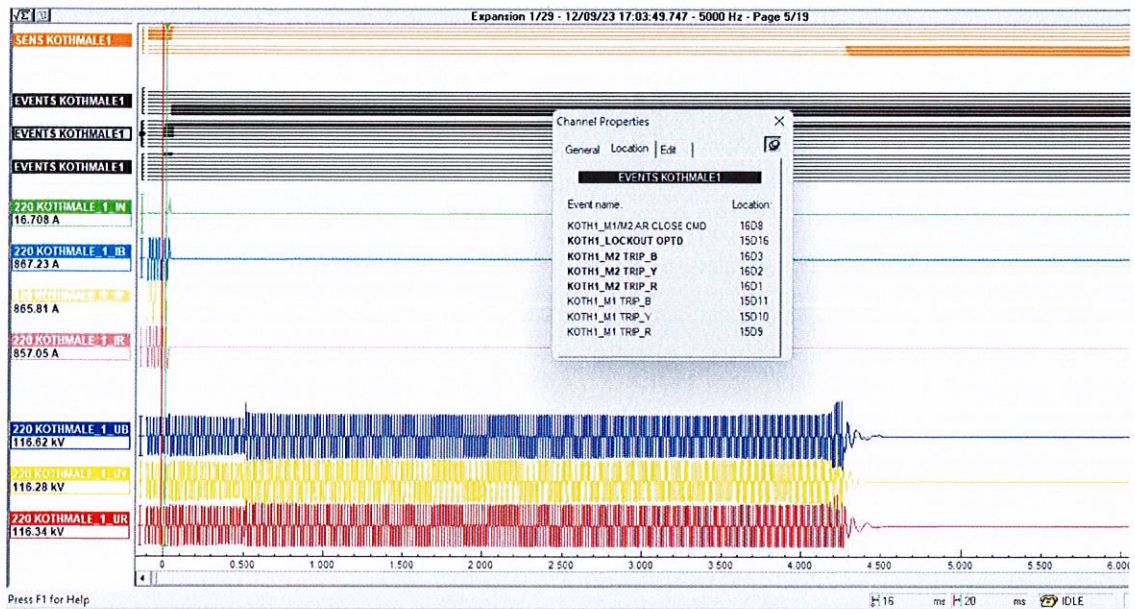
Figure 07: DDR record of Kothmale line 1 of New Habarana GSS at 17:03:49 Hrs

- (3) After the power swing condition, the load current of New Habarana – Kothmale line 01 & 02 has reached around 850A which exceeded the overcurrent setting 800A (with tms 0.21) leading to the tripping of New Habarana – Kothmale line 01 at 17:03:49 hrs. This further overloaded New Habarana Kothmale line 2 resulting in the tripping of the line at 17:03:50 hrs. Subsequently Kothmale end frequency has increased up to 63Hz and the frequency Biyagama/Norochcholai side of the network has dropped to 40Hz resulting in the total system failure.

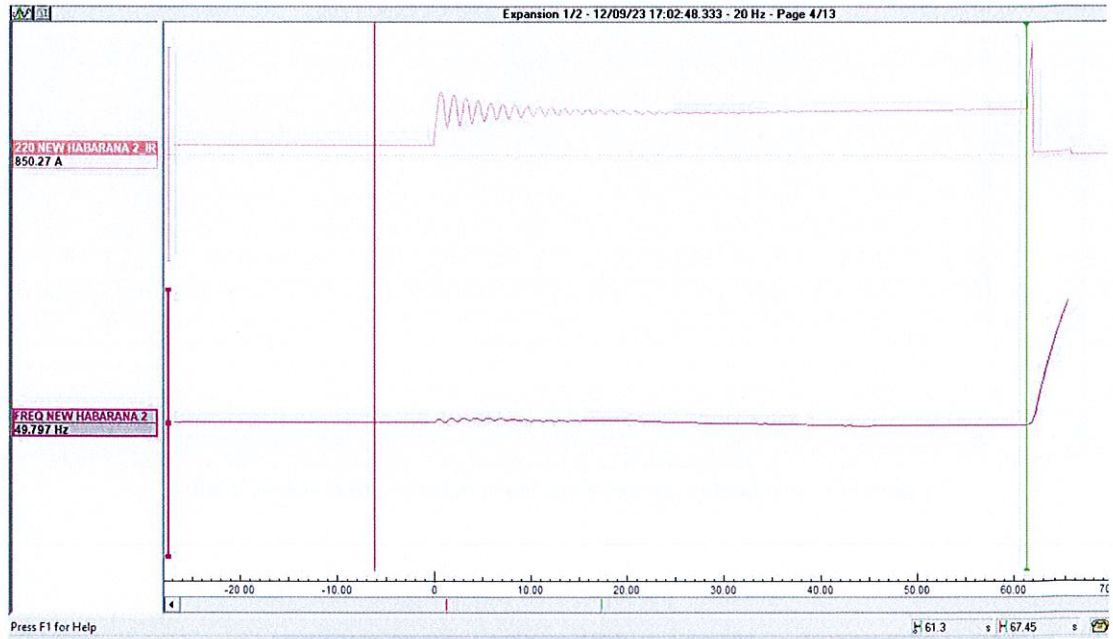
Figure 09: Frequency variation at Kothmale 220kV Bus

- (2) After the tripping of Biyagama Kothmale line 01 and 02, power swing was detected in the Kothmale – New Habarana lines lasting approximately 20 seconds and subsequent stabilizing while maintaining the system frequency above 49.7Hz. (Refer figure 9,10 & 11)
