Public Utilities Commission of Sri Lanka

Report on Compliance of Distribution Substations with Electricity Safety Quality and Continuity Regulations

January 2025

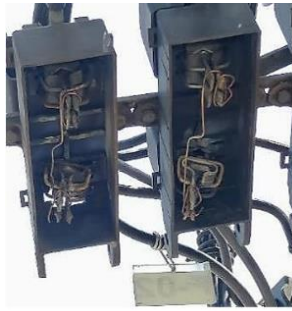
N-15*
Nikaweratiya

Observations: Substitution of standard fuses with copper/aluminum wires.

Weakly connected HRC fuses causing severe hotspots.

Unenclosed HRC fuses at touchable height causing exposed live parts.

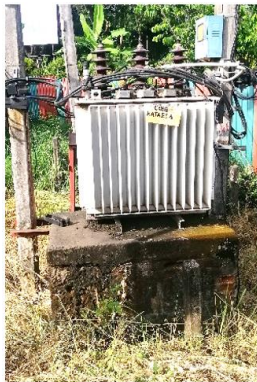
C-018
Minneriya

Observations : Inadequate barriers to prevent accidental access to exposed live parts

Explanation: Some substations, specially the plinth mounted substations have open live parts and inadequate barriers, posing significant risks to public safety. Substations should have appropriate enclosures to prevent unauthorized access and reduce the risk of injury.

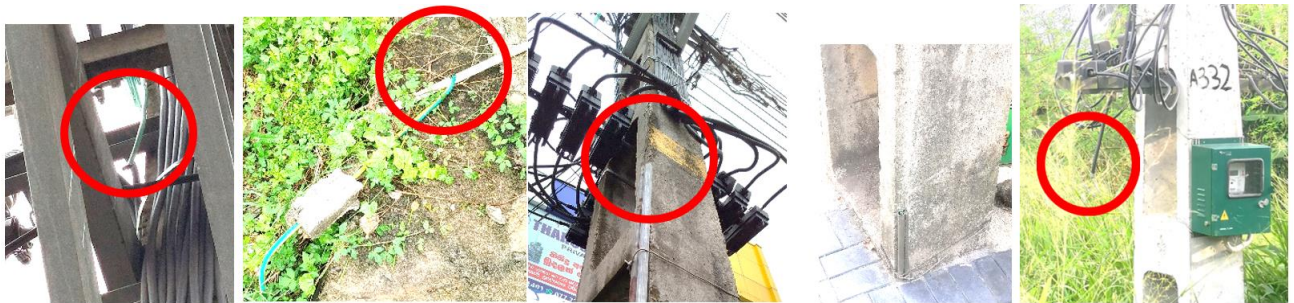
Observations: Removal(theft) of surge arrester earth.

Removal(theft) of neutral earth.

Explanation: Several transformers and surge arresters lack proper earthing connections (owing to theft), increasing the risk of electrical faults and equipment damage. Further it was observed that use of aluminum cables to reconnect the void of removed portion of the copper earth cable.

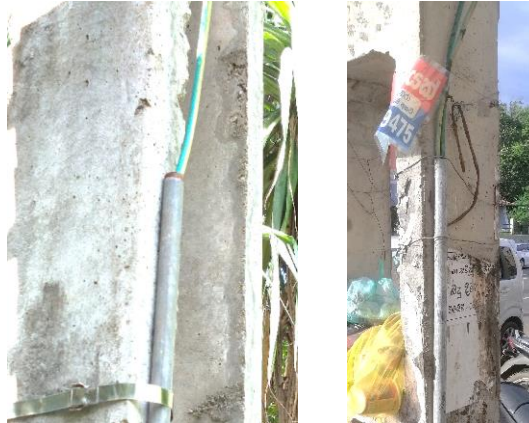
Use of metal pipes to cover surge arrester earth wire.

As per the information provided by CEB, down conductors of earthing are passed through a PVC pipe filled with concrete or cement. However, we have come across places where metal tubes have been used for the same purpose. From an electrical perspective, this method requires careful consideration to avoid affecting the earthing system's performance during surge events due to a potential increase in inductance.

- iv. DL to Evaluate the consequences (increased inductance) of using steel enclosures (eg: GI pipes) to protect earthing wires (from theft) of substation. Accordingly decide and provide instructions to areas where they are using steel pipes to encase surge arrester earth wires to prevent theft.

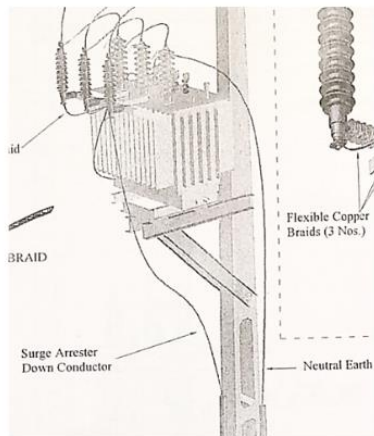
2 earth wires

Use of 2 separate earth wires for surge arrester earth and transformer body earth (against the CEB distribution construction standard- 2023).
