**Total System Failure occurred on 09<sup>th</sup> February 2025**

REPORT OF THE COMMITTEE TO INVESTIGATE  
THE TOTAL POWER SYSTEM FAILURE  
OCCURRED ON 09-02-2025 AT 11:14 HRS

April 2025  
Ceylon Electricity Board

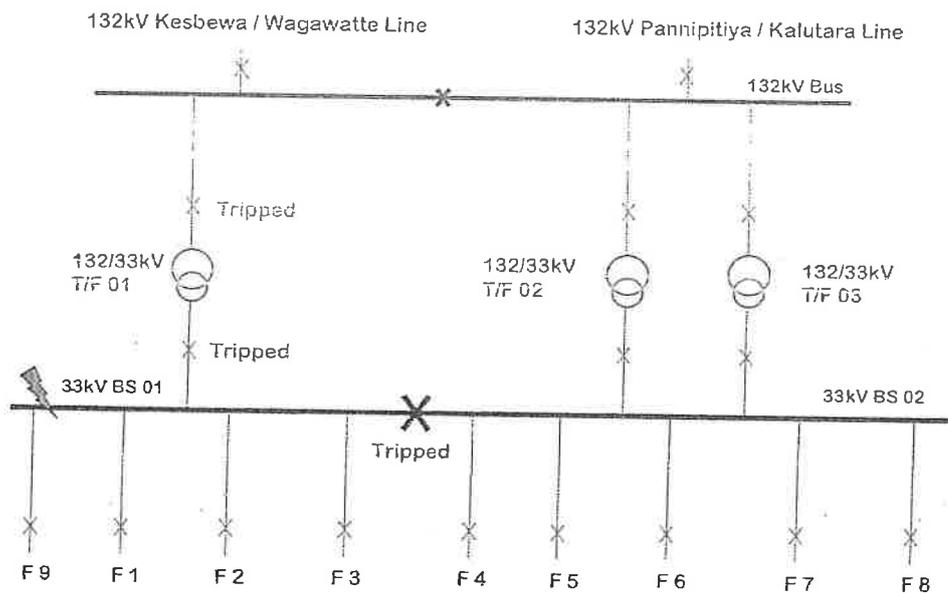
Figure E1: SLD of Panadura GSS with fault location and CB operations

According to the DFR record at the Kesbewa Grid Substation (GSS), a double line (R and Y phase) to ground fault occurred at 11.13.39.476 ms on the said date at 33 kV busbar of Pandura GSS as shown in Figure E1 due to contact of a Monkey. The fault was cleared partially with the operation of overcurrent protection of 33 kV Bus Section after 484 ms from fault initiation. It was noted that the 33 kV bus voltage has dropped to 60% of the normal voltage during the fault and recovered to 80% after the operation of overcurrent protection. With the opening of Bus Section breaker, the fault was feeding through Transformer 1 and it was cleared by the operation of overcurrent protection of 33 kV side breaker of transformer 1 after 1.034 sec from the fault initiation.

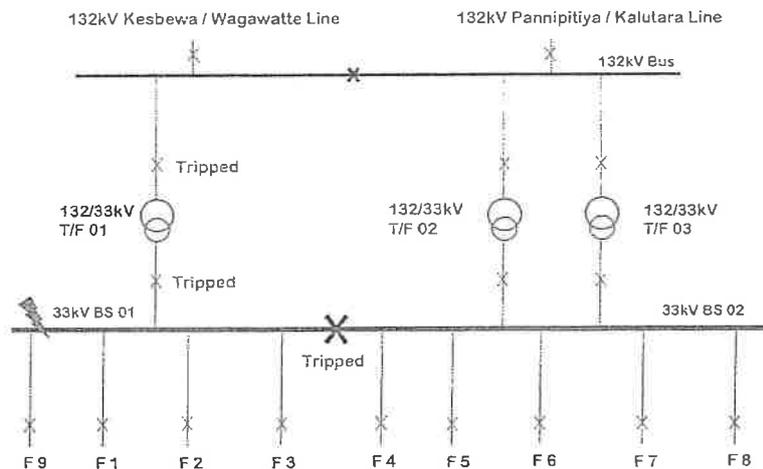
Figure 3.1- SLD of Panadura GSS with fault location and CB operations

According to the records, a phase to phase to earth fault has occurred at 33kV bus section 1 of Panadura GSS at 11:13:39.520 hrs on 09th February 2025 caused by the contact of a monkey with L1 and L2 phases of 33kV bus bars and the earth as shown in figure 3.1.

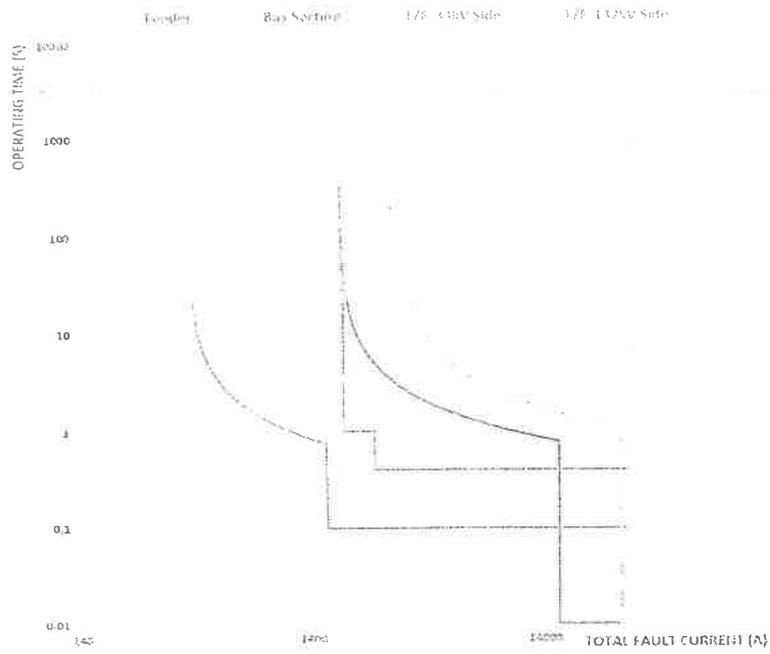
Figure 3.2- Overcurrent setting coordination at 33kV side of Panadura GSS

Setting coordination graphs to verify the availability of adequate coordination for above settings between the circuit breakers for a fault occurred in a 33kV feeder is shown figure 3.2 and 3.3. Numerical relays with fault recorders are not available in transformer 1. Hence, fault currents during the incident were derived from numerical relay records and Ben disturbance recorders installed at nearby substations.

According to the overcurrent and earth fault protection setting of Bus, the coordination curves were given in Figure 3.2 and 3.3 in Chapter 3 above. Since there was no fault current through 33 kV feeders the protection coordination was between Bus Section and 33 kV side of the transformers. Thus, for a fault current of 5.3 kA through bus section, the relay will operate instantaneously after 0.4 s delay. It was noted from the recorded operating time was 0.485 s which is the delay plus the breaker operation time. Hence the relay has operated according to the set value. Once the bus section breaker was operated, the fault current has flown only through the transformer 1. Hence, the overcurrent relay of transformer 1 was operated. The operation time will follow the IDMT curve. The time to operate for IDMT curve with IEC 60255 is given by following equation.

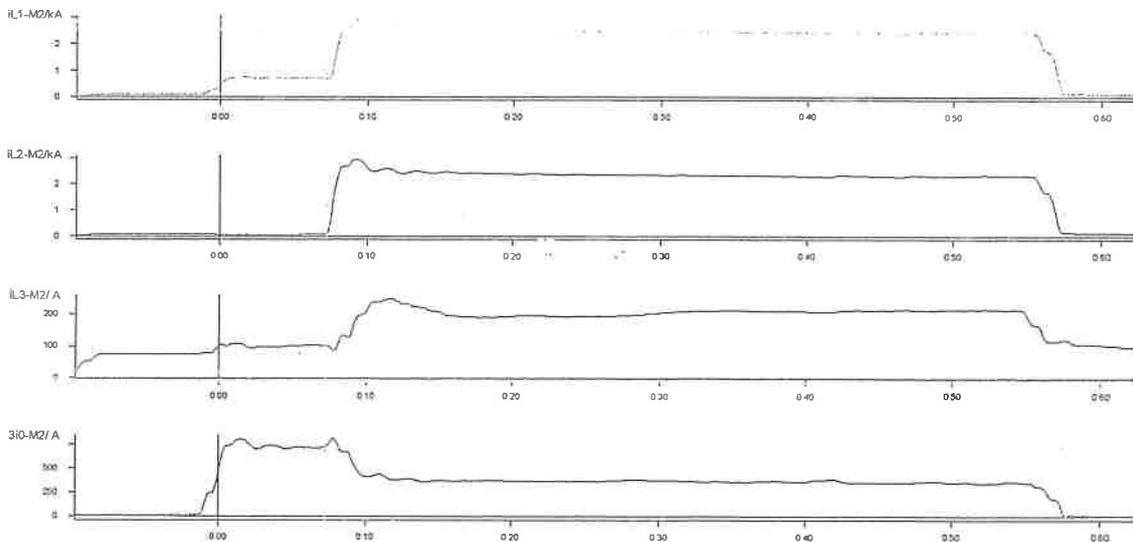
Figure 4.2- Recorded current of 33 kV side of transformer 3

4.5 below. According to the disturbance records available in Siemens 7UT main protection relay in Transformer 3, it can be observed that initially Phase R to earth fault with magnitude of around 740 A has occurred, which is approximately a fault current of 2.2kA assuming equal contribution from all three transformers. After 75ms as shown in Figure 3.2, fault developed in to L1-L2-Earth fault of 2.65kA, which resulted in a total fault current of around 7.95kA, and a fault current of 5.3kA through 33kV bus section triggering the operation of Definite Time Over Current protection set to pick up at 1700A and operate with a time delay of 400ms. Accordingly, the bus section has tripped in 480ms inclusive of circuit breaker operation time.

The earth fault current as shown in Figure 4.2 has increased to around 750 A for 100 ms and dropped to around 375 A. Therefore, it takes about 800 ms to activate the earth fault relay for this fault current. Thus, bus section fault will activate before the earth fault for the existing relay settings. Therefore, the earth fault relay was not operated at this instant.

With the tripping of the 33kV bus section, fault was fed only through Transformer 1. Based on the currents recorded in the incoming lines, the 33kV fault current of Transformer 1 was approximately 4 kA. The transformer 1 has tripped by the operation of IDMT over current protection within 1.1 seconds completely isolating the faulty bus section with the simultaneous operation of both 132kV and 33kV side circuit breakers.

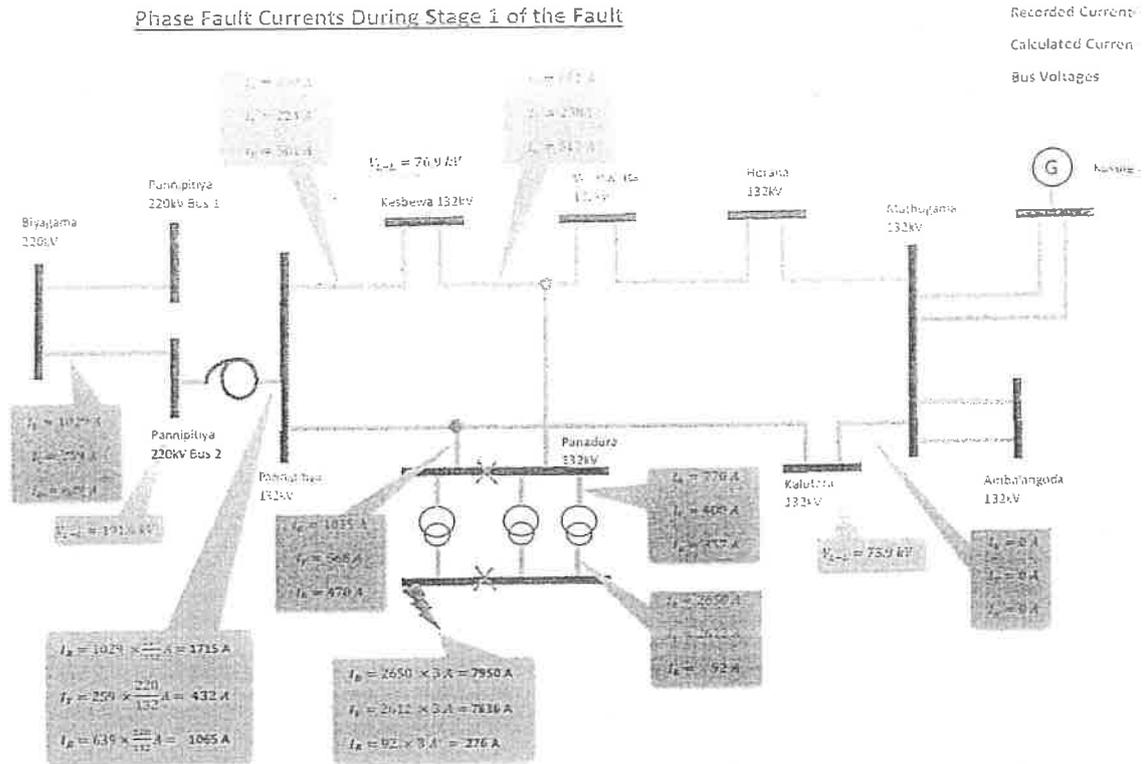
Figure 4.3- Fault currents during the incident derived to validate operating times

Fault has been cleared in 1.064 seconds and no other transmission lines/ transformers or generation plants have tripped. System voltage has returned to normal values with the clearing of the fault. During the fault period, system frequency has sustained within the normal limits. No other faults or disturbances were observed during the above fault time.

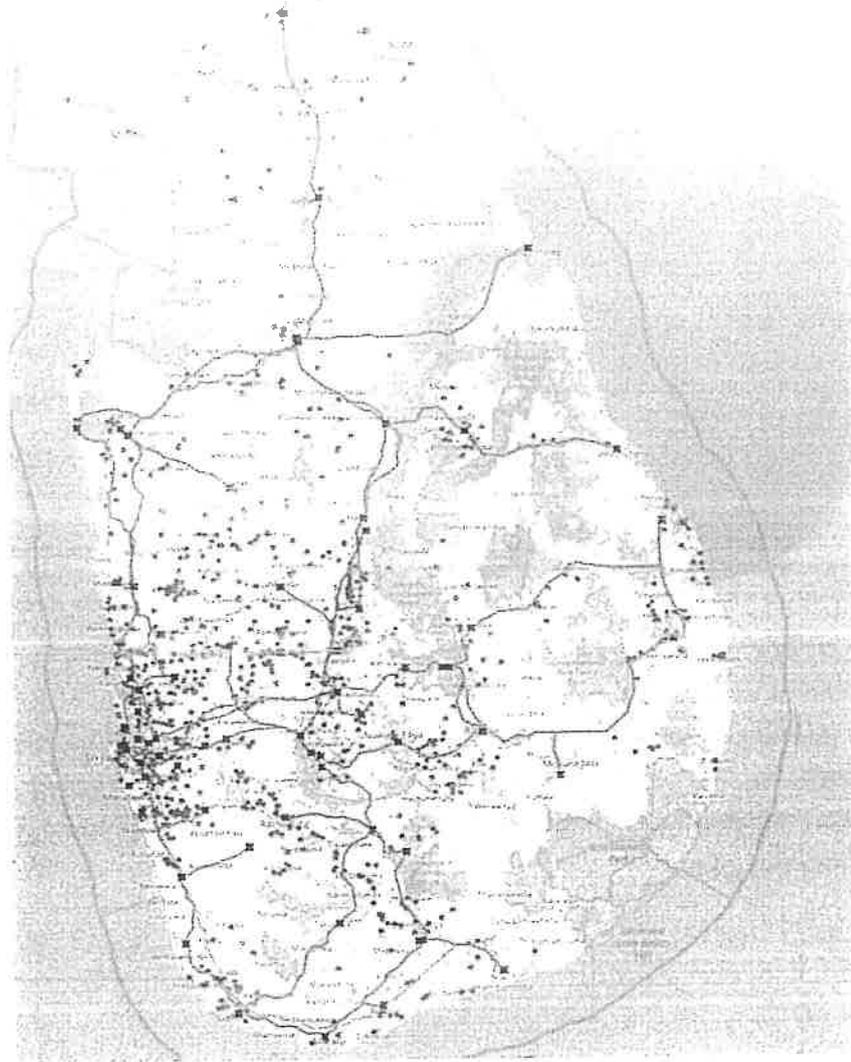
Figure 5.1- Graphical representation of island wide RTSPV Inverter behavior of the randomly collected samples

As per the collected data from the randomly selected samples of the RTSPV inverters, it was identified that the RTSPV inverter tripping have occurred based on the main three reasons. Although the different types of inverters have presented the tripping reason in a slightly different way, the collected data are summarized and shown in the map as follows.

- ▣ RTSPV Inverter tripping reasons due to No Grid / Grid Loss / Utility power loss/ CEB power failure/ No AC power are shown in **green dots**
- ▣ RTSPV Inverter tripping reasons due to Under frequency of the network/ frequency fault/Grid UF fault/ Grid UF/ low frequency / UFP2 are shown in **red dots**
- ▣ RTSPV Inverter tripping reasons due to Grid under voltage/Grid Low voltage/ AC voltage too low / U voltage / Grid OV are shown in **yellow dots**

As per the collected data, committee observed that the most of the RTSPV inverters connected to the distribution network fed from Wimalasurendra, Nawalapitiya, Ragala, Nuwaraeliya, Embilipitiya, Balangoda, Ambalangoda, Bolawatta, Balangoda have been disconnected due to under frequency of the network.

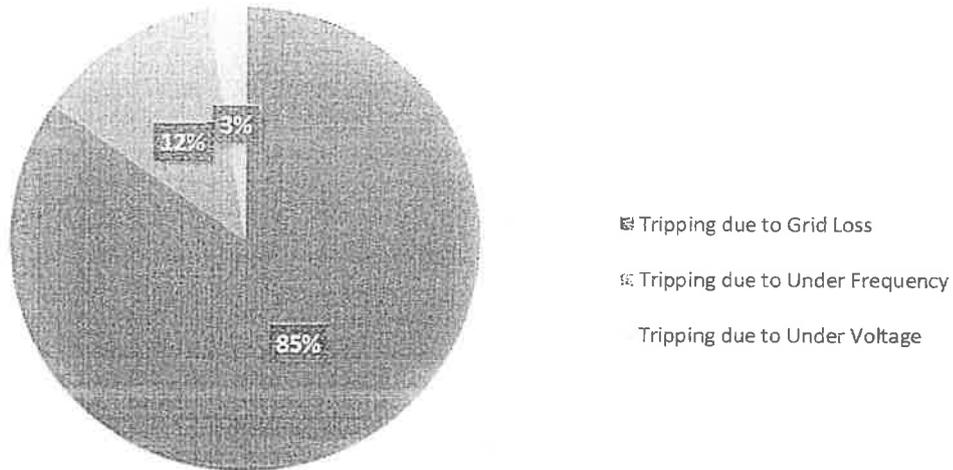
*Figure 5.2- Identified number of RTSPV systems disconnected due to Grid loss/ Under Frequency of the network/ Under Voltage of the network*

It is identified that more than 15% of the RTSPV systems attached to CEB out of total selected samples have been disconnected from the distribution network due to under frequency and the under voltage of the network during the fault.

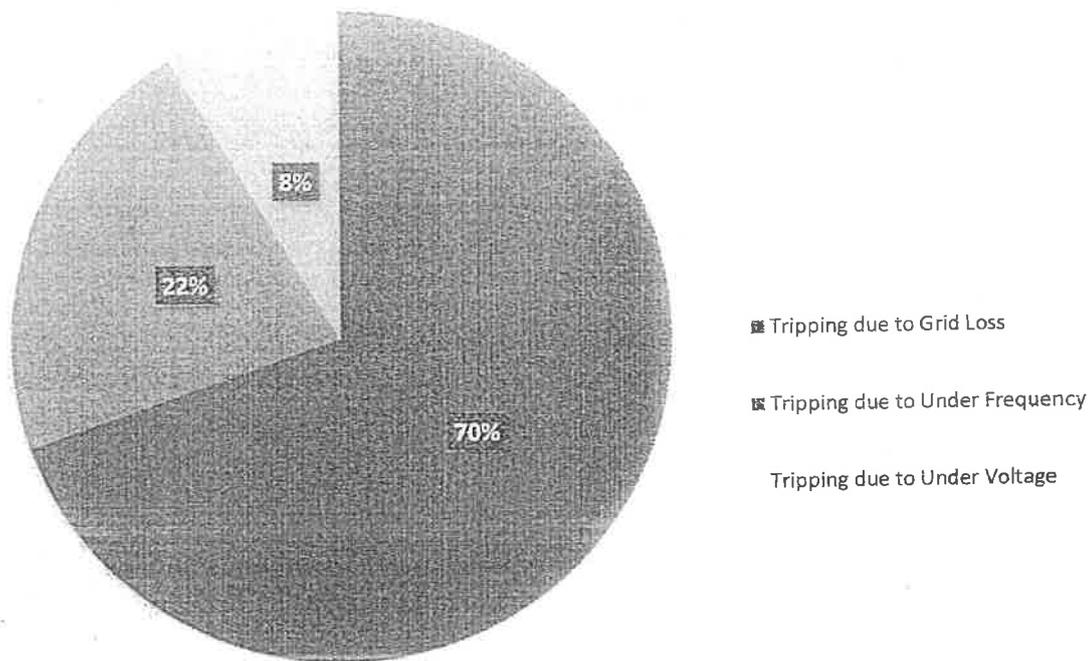
Figure 5.3- Capacity of RTSPV systems disconnected due to Grid loss/ Under Frequency of the network/ Under Voltage of the network

Further as per the table 3 above, it is identified that more than 30% of the RTSPV systems capacities attached to CEB out of total selected RTSPV systems capacities have been disconnected from the distribution network due to under frequency and the under voltage of the network during the fault.
