**Total System Failure occurred on 09<sup>th</sup> February 2025**

REPORT OF THE COMMITTEE TO INVESTIGATE  
THE TOTAL POWER SYSTEM FAILURE  
OCCURRED ON 09-02-2025 AT 11:14 HRS

April 2025  
Ceylon Electricity Board

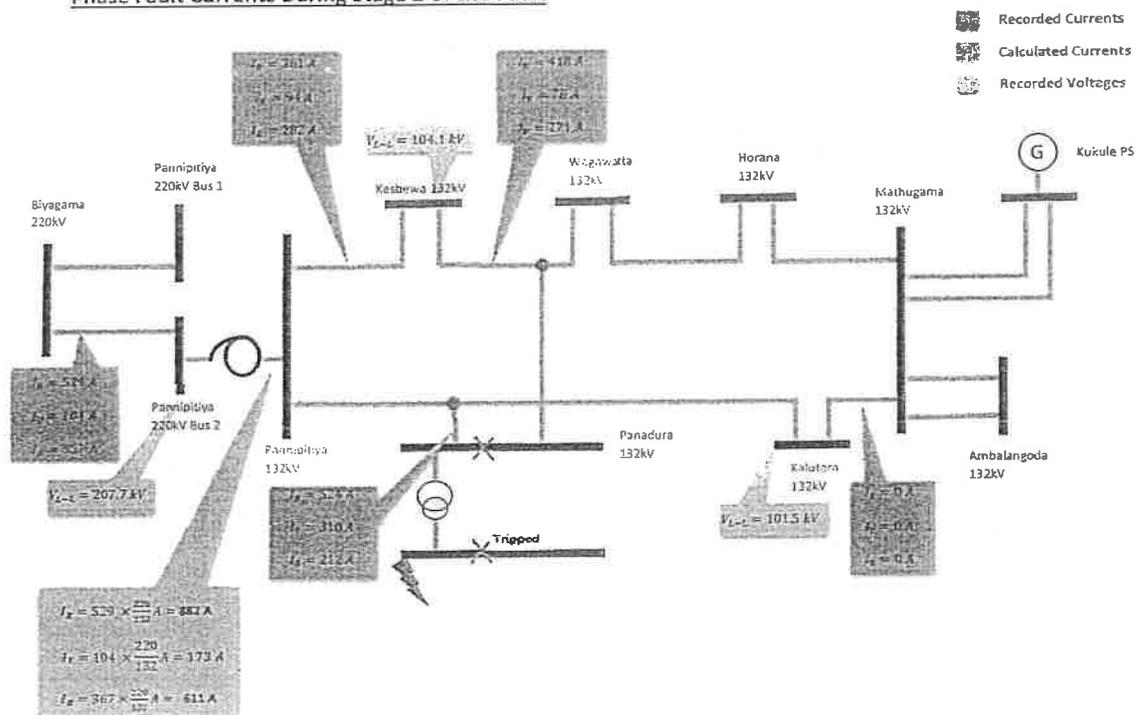
Figure 4.4- Fault currents during the incident derived to validate operating times

### Phase Fault Currents During Stage 2 of the Fault

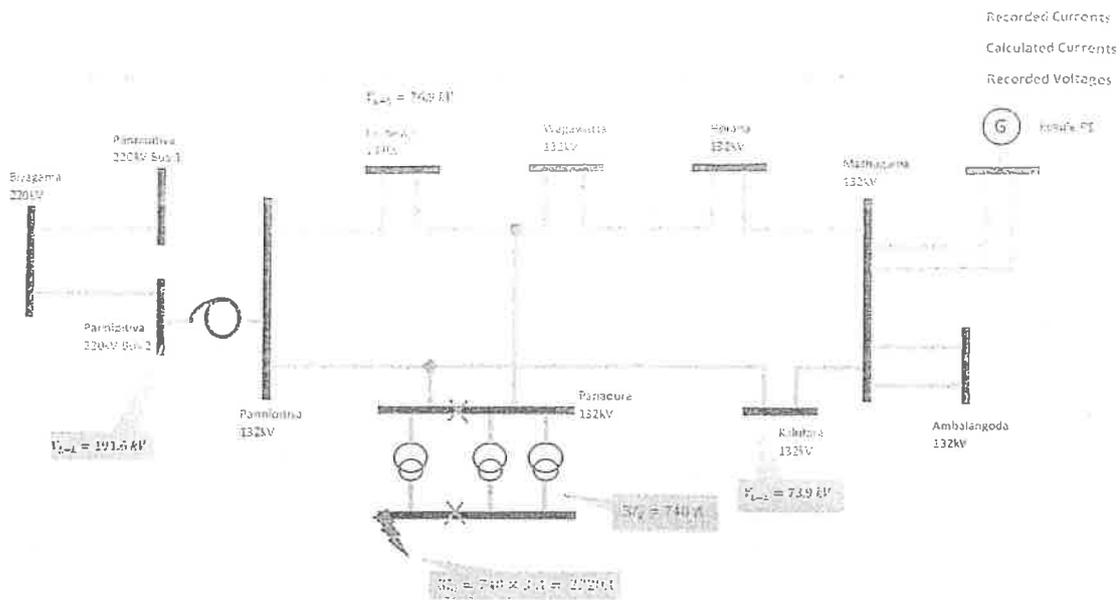
Figure 4.5- Earth fault currents derived to validate operating times

### Earth Fault Currents and Operating time of each relay During the Stage I of the Fault

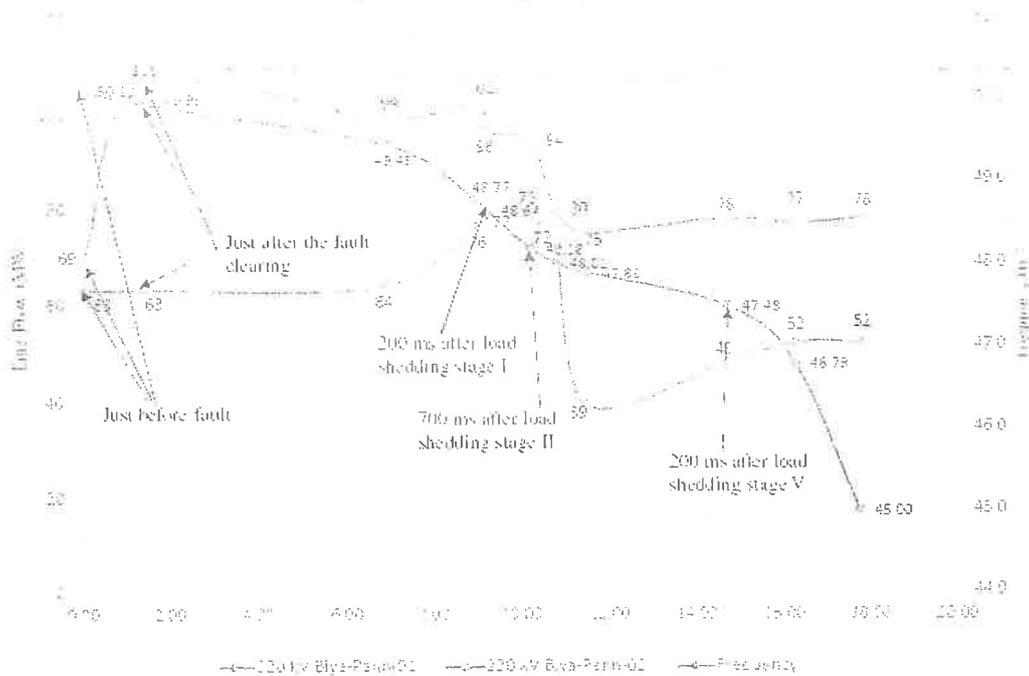
Figure 6.2- Biyagama-Pannipitiya Line 1 and Line 2 active power flows during the system failure

In order to further validate this argument, load currents of transmission lines were analyzed through the DFR records which were shown in Annex 11. The extract from these records is shown in Figure 6.1. The Pandura, Kesbewa, Kalutara, Mathugama Grid Substations were fed through 132 kV transmission line emanating from Pannipitiya 220/132 kV Substation. The incoming 220 kV line for this substation is Biyagama-Pannipitiya 2 and it was supplying 69 MW just before the fault. However, it was noticed the flow has increased to 106 MW which was a 37 MW increase. Similar behavior could be observed in other major transmission lines as well. Since there was no other generator tripping, there was a substantial amount of generation lost just after fault. Thus, this has led to start the system frequency to drop at a rate of 0.11 Hz/sec. The rate of change system frequency has increased from 0.11 H/sec to 0.18 Hz/sec just after the frequency reached to a value below 49.5 Hz. This was due to the reason that underfrequency setting of certain amounts of rooftop solar PV inverters as discussed in Chapter 5 was 49.5 Hz. The same could be further justified when the 220 kV and 132 kV line flows as shown in Figure 6.2 were analyzed. The system frequency was continuously reducing for approximately 2.8 sec till the system frequency reached to 49.0 Hz. Once the system frequency reached just below 49 Hz the RTSPV inverters which have been configured to disconnect just below 49.5 Hz has been tripped and the system frequency falling rate then increased to 0.47 Hz/sec. The load shedding stage I was activated at the frequency of 48.75 Hz. However, there

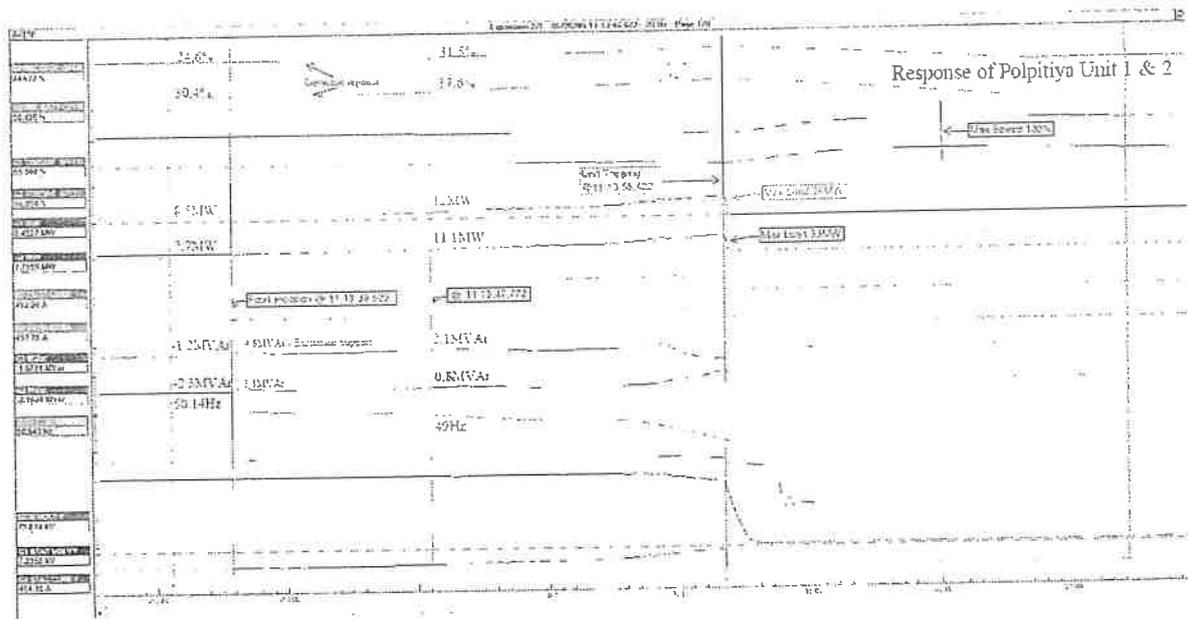
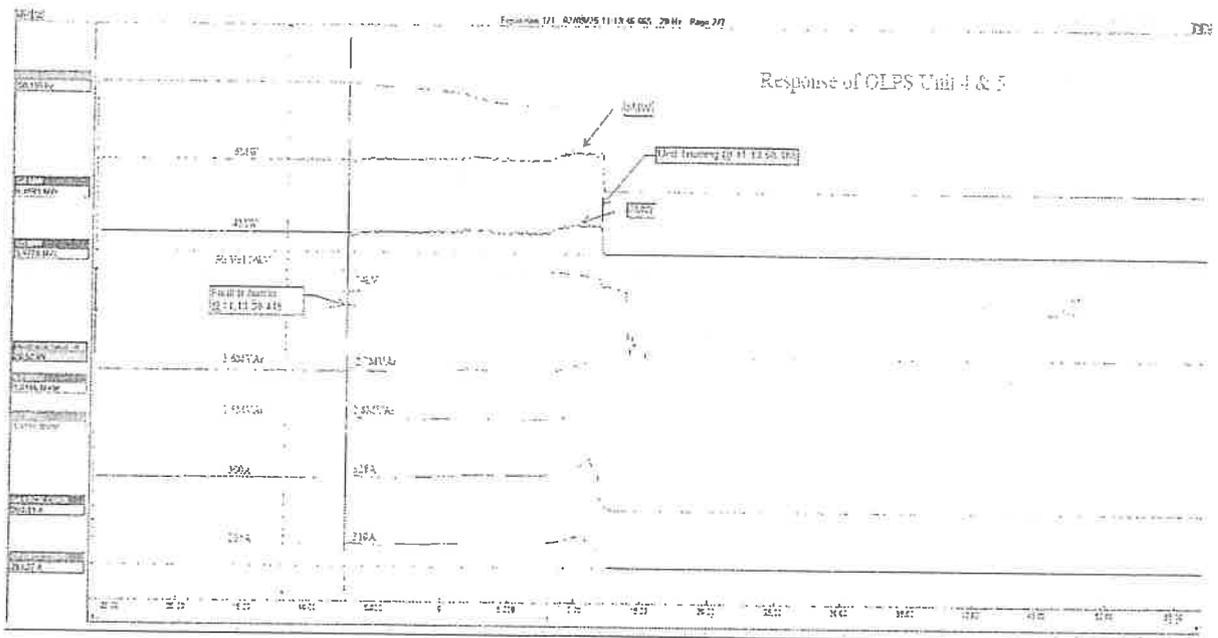
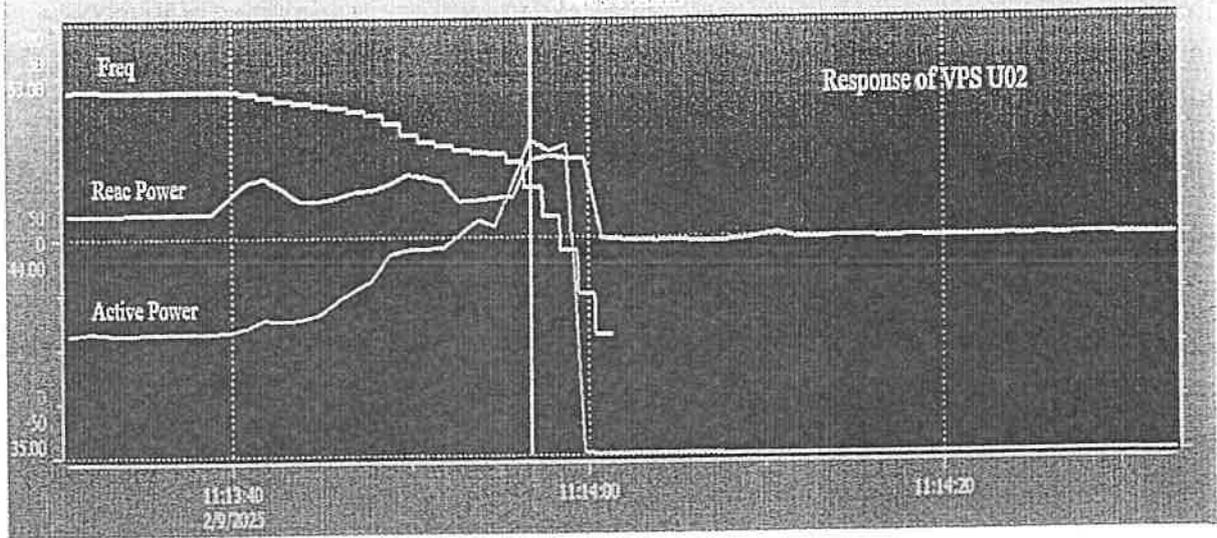
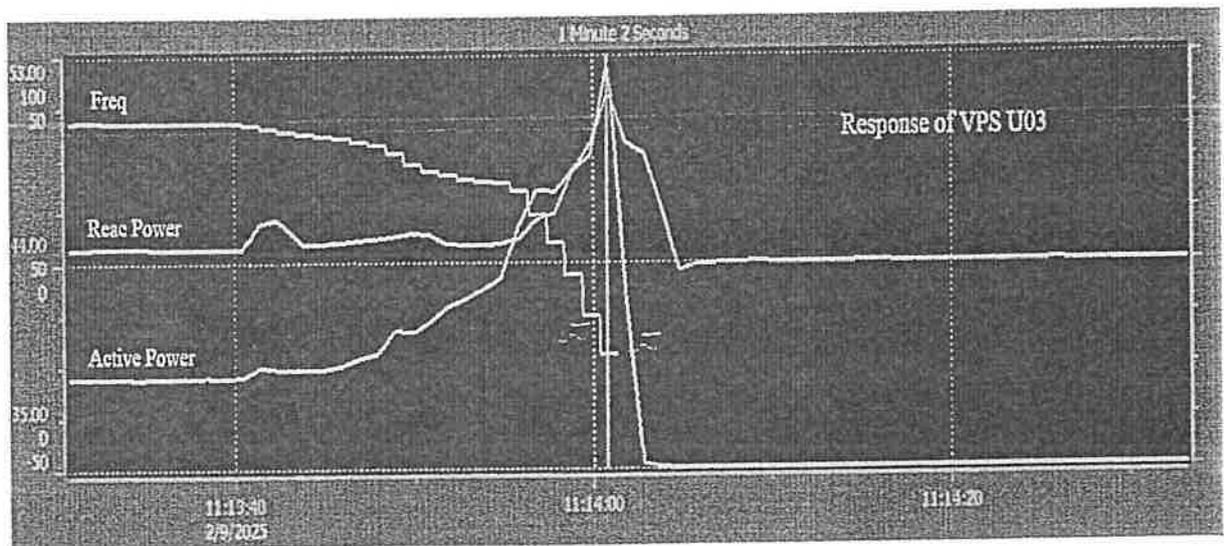
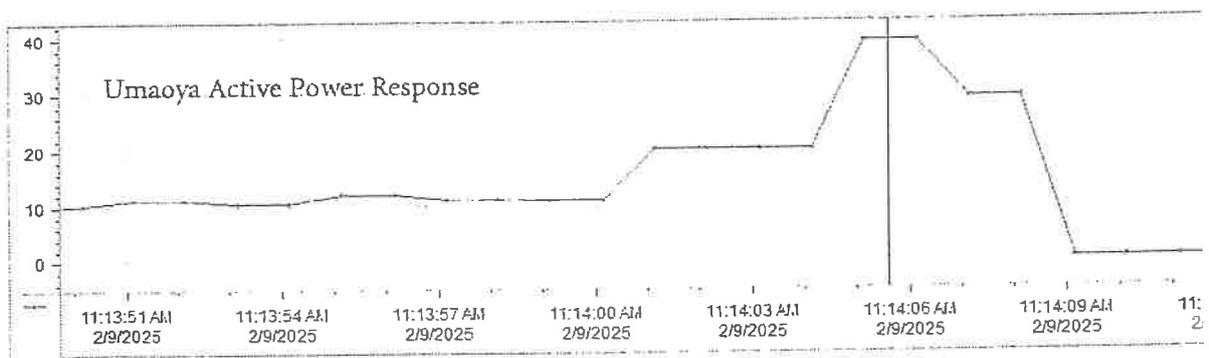
The active power response of 11 Unit of six power plants have been depicted in Figure 6.3 to Figure 6.9. The analysis was carried out using the frequency response given in Figure 6.1.

Assuming initiation time of the fault as 0.0 sec (Actual time was 11:13:39.476 hrs) for the convenience of the analysis, Region A considered as during the fault which last for 1.2 sec. the rate of change of frequency (ROCOF) during this was approximately 0.18 H/sec and the fault current was about 7.9 kA with a R and Y phase to ground fault. It was seen from Figure 6.3 to Figure 6.9 that all the units were responded to correct system frequency and the voltage. The calculated inertial responses and voltage correction responses are given table 6.1.

After the fault was cleared by opening of 33 kV Bus Section breaker and 33 kV side breaker of transformer 1 at Panadura Grid Substation, system frequency was 49.95 and the system ROCOF was 0.11Hz/sec. It was clear that the system frequency was slowly decreasing and it reached to 49.5 Hz after 5.5 sec from the fault initiation time. The Ruring Units were supporting to correct the frequency as given in Figure 6.3 to Figure 6.8. The calculated inertial responses and Primary Responses are given table 6.2.

It appeared that due to the double line to ground fault initiated at 33 kV busbar of Panadura GSS led to drop the system voltage by nearly 40% at Panadura and other Grid Substations nearby to Panadura Grid Substation. This caused to take away certain amount of inverter-based generation from the system leading draw more power from the running generators starting system frequency to fall. The analysis of inverter settings of RTSPV systems, considerable portion of them were set to trip 49.5 Hz and 94% of nominal voltage. Thus, continuous drop of the system frequency took place leading activation of IV stages of UFLS. However, the shed load was not as expected due to not updating the UFLS since 2014. The UFLS feeders too connected with Solar PV generation and fed the consideration number of loads in those feeders. It was noticed that some feeders were back feeding and tripping of these feeders has aggravated the system condition bring to the stable operation. Due to the reasons stated above the total system failure was unable to stop.
